**2010 QUINQUENNIAL INSPECTION
ALL SAINTS CHURCH, HARTBURN VILLAGE, STOCKTON ON TEES**

Diocese of Durham

July 2010

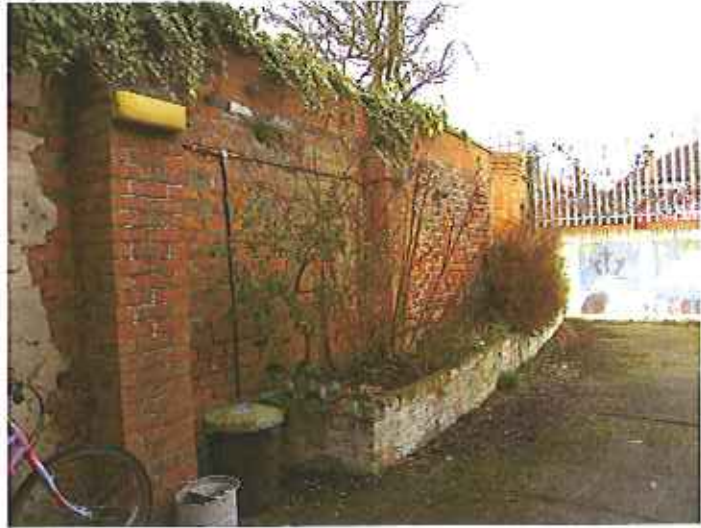
Rear Yard: Enclosed area with tamped concrete surface: the west wall is of 19th century pierced brickwork approximately 3000 mm high – it leans into the yard and is cracked. A tell-tale template has been installed to monitor the crack.

3. West boundary wall, yard area to North of church

3.4.2 The last QI report advised that a structural engineer should check the stability of the leaning west wall. It does not appear to be moving but a careful check should be undertaken at least annually and if any further movement is suspected then a more detailed investigation should be immediately instigated.

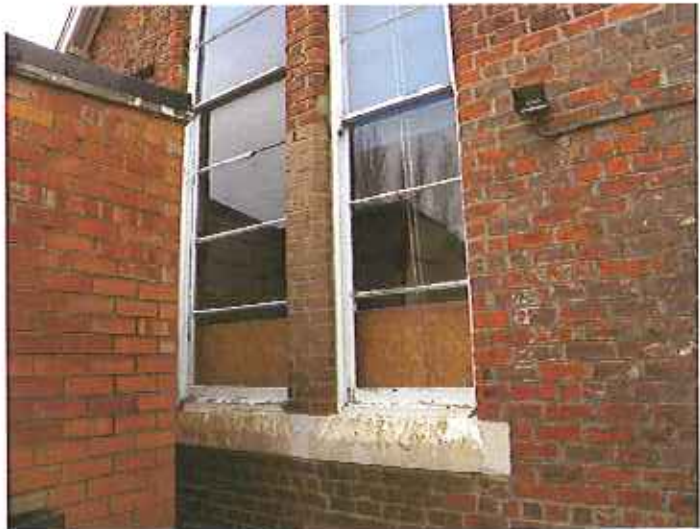
External paintwork requires attention at rear (north side): removal of loose coatings, patch priming, undercoat and full gloss coatings are required to timber surfaces within the next 12 months. Some eills require patch repairs to timber before redecoration.

6. External view, North wall of church

3.3.2 Clean down check for any rot, prepare, undercoat and redecorate external woodwork on north side of building.

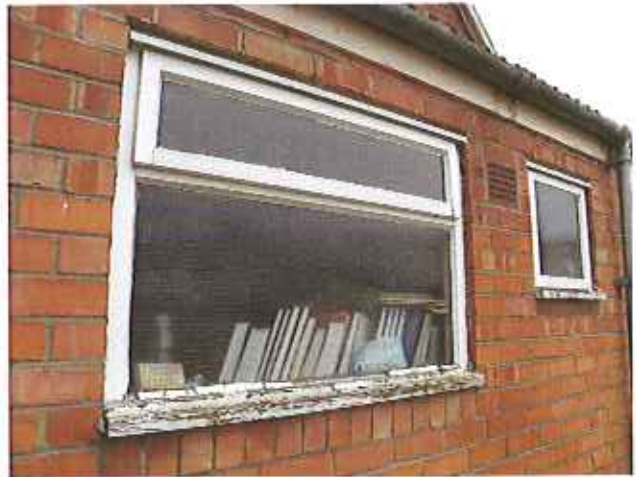
10. North wall, external view (window detail)

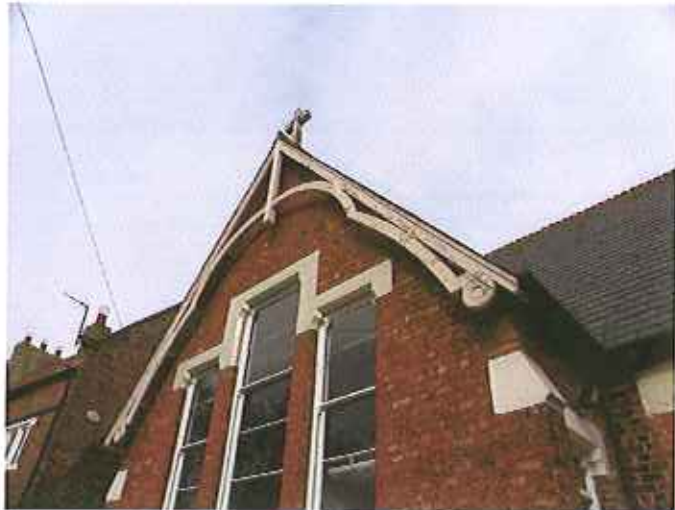
15. South facing gable (detail)

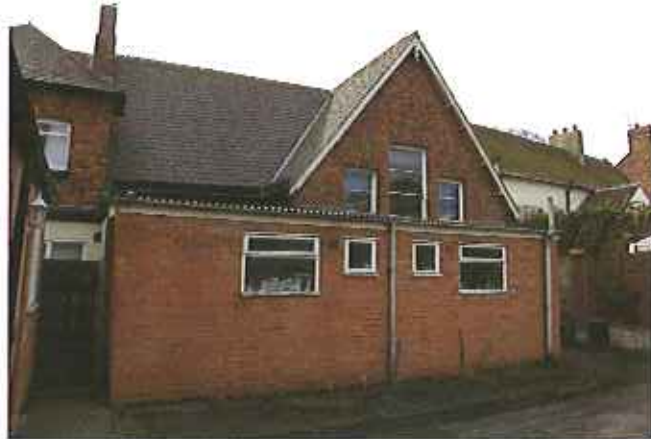
17. North elevation including ancillary accommodation

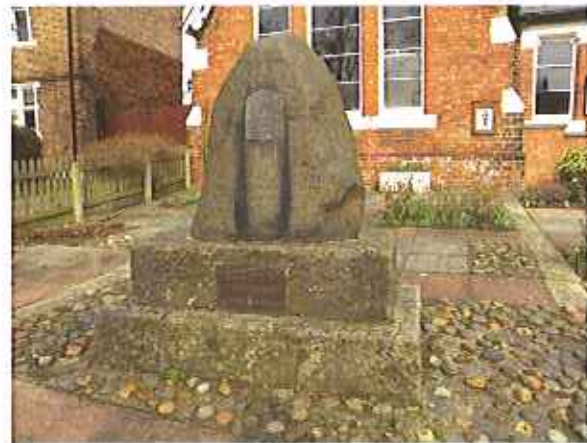
- 2.3.1 There is a memorial stone (see photograph 18) in the south facing garden commemorating the 60th year of the reign of Queen Victoria which was erected in June 1897.
- 2.3.2 The original building incorporated a steeple (see photograph 7). The pencil sketch shows it to be in place in 1907. It is not known when this was demolished, but probably during the adaptations in the 1920s.
- 2.3.3 The building is not listed.
- 2.3.4 The church is mentioned (but without further comment) in Pevsner's Buildings of England, Durham, p 444.

18. Memorial stone in garden to South
