Job No. 11.55
QUINQUENNIAL
CHURCH OF ST PHILIP AND ST JAMES

John Taylor
Architects Ltd

QUINQUENNIAL INSPECTION

Quinquennial Report October 2011

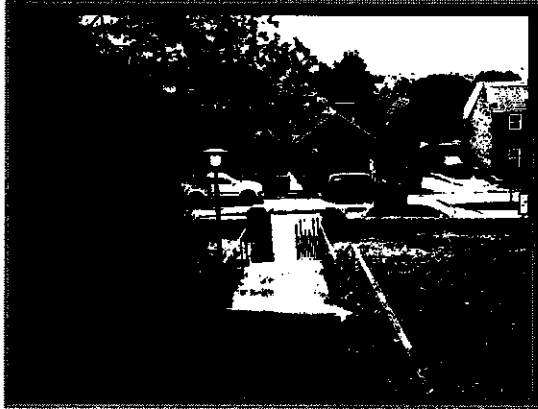
The site falls from North to South and consequently the Church on the North and East side is set below ground level by approximately 1.5m in the worst case. The building is protected by a footpath and then a stone retaining wall set approximately 1.0m from the building face. The retaining wall to the North side contains field drain outlets discharging water from higher ground.

(Main access from the south, indicating fall)

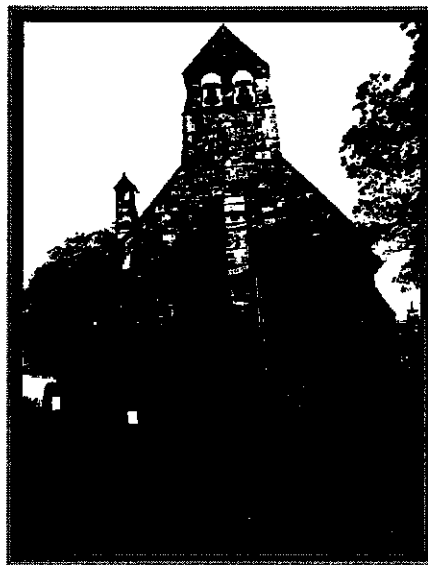
Main West elevation and bell tower stonework generally sound and in good order. Isolated areas of repointing required. Fine settlement crack evident, appears quite old. Bell tower has two bells on timber mounting blocks with cast iron brackets generally all sound. Lighting conductor located on bell tower has been disconnected. Electricity transformer mounted at high level on North West corner.

The lighting conductor is a matter of urgency for the church.

(Lighting conductor located on bell tower has been disconnected)

- a) Clean out all rainwater goods.
- b) Reinstall copper lighting conductor.
- c) Clean out all blocked, trapped gullies.
- d) Form concrete step to boiler house.
- e) Pointing paving slabs to main footpath.
- f) Remove moss from North side footpath and ensure operation of open drainage channel.
- g) Replace lead abutment and upstand flashings to vestry roof.

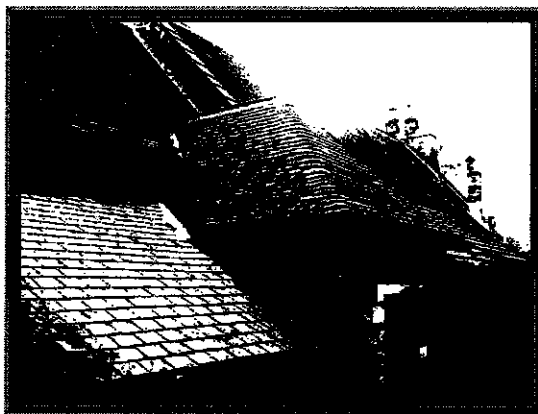
Vestry roof is Welsh slate in good order with isolated slates slipped. Abutment lead flashing at both East and West end of roof and upstand. Lead flashing to main church wall have been removed.

(Missing lead flashing to North elevation)
