INSPECTION AND REPAIR OF CHURCHES

Care of Churches Measure 1991

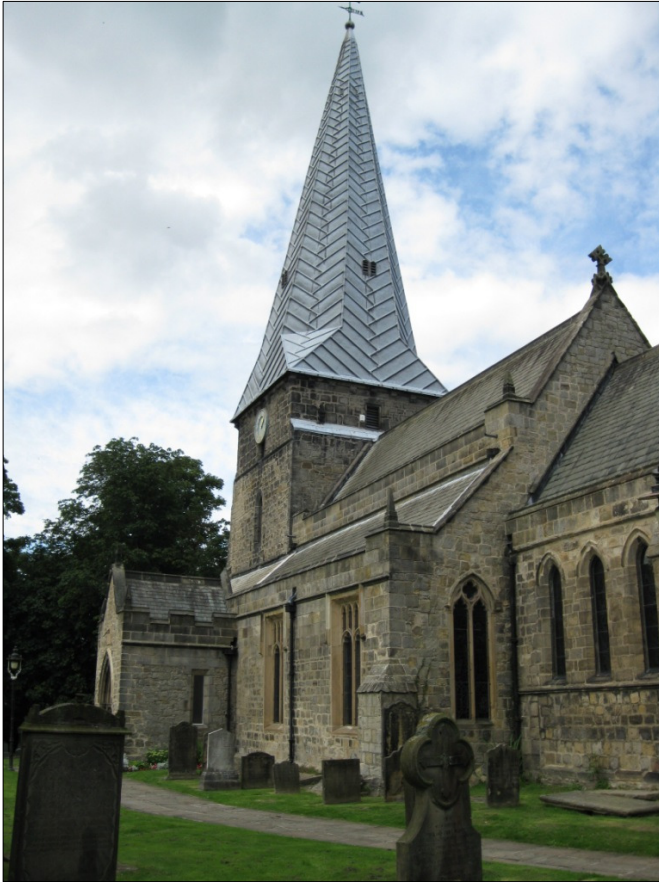
General view of South side of Church and Spire

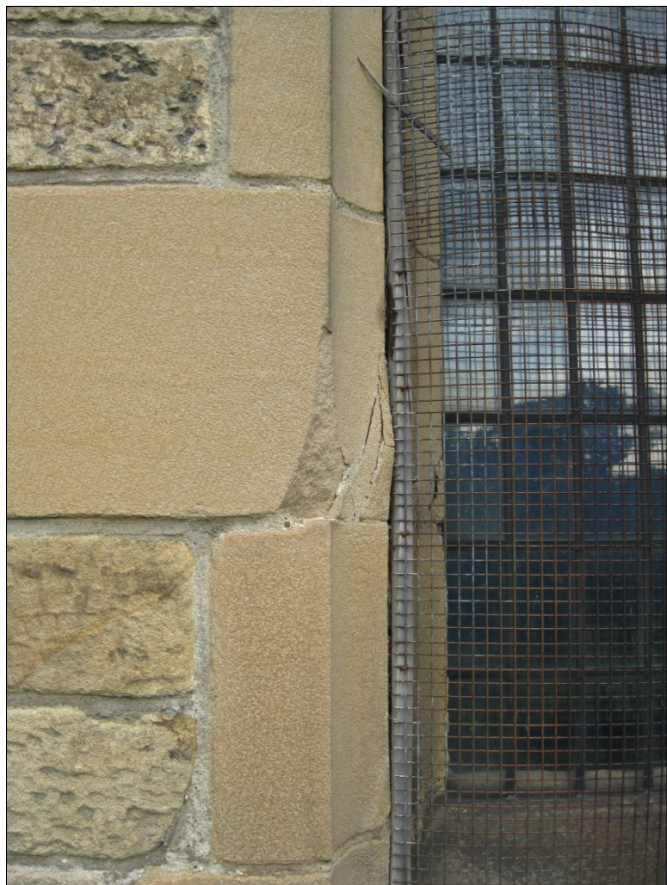
Spalled window jamb: South Aisle, West of Porch

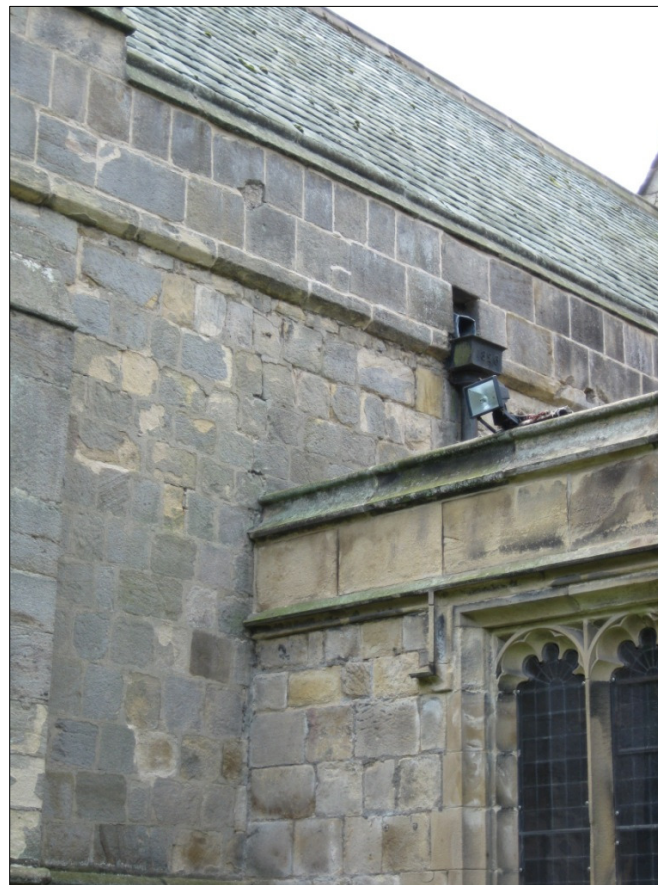
Open joints in wall of Chancel above Vestry roof
