**DIOCESE OF DURHAM  
HOLY TRINITY CHURCH,  
SEATON CAREW, COUNTY DURHAM TS24 7QX**

**INSPECTION OF CHURCHES MEASURE 1955  
CARE OF CHURCHES & ECCLESIASTICAL JURISDICTION MEASURE 1991  
QUINQUENNIAL INSPECTION 18 AUGUST 2010 AND REPORT OCTOBER 2010**

**David Beaumont BA (Hons) GradDip, RIBA, AABC**

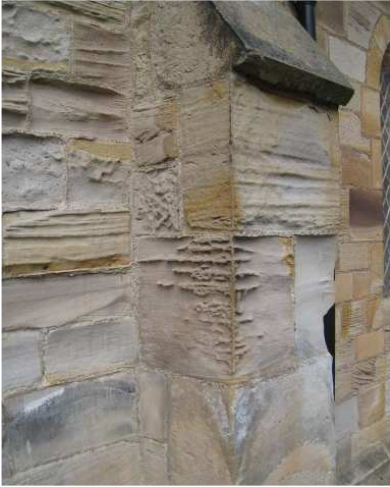
**BUTTRESS BE3 EROSION**

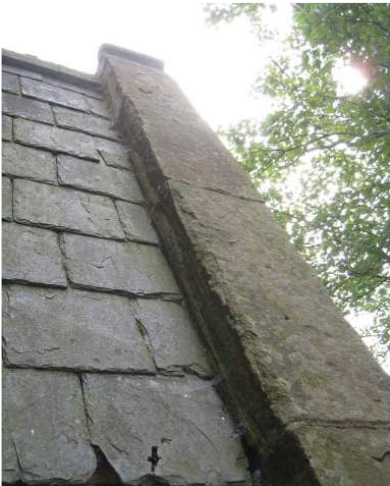
**Porch:** The porch to the chancel is really quite nice as it has less of the monumental scale of the Nave. The ridge tiles look to be breaking up, the slating is chipped at the foot and its abutment to the sanctuary and porch gable is in mortar. Not much cover on the porch gable, piece missing on the western face needs filling. Polycarbonate guard to trefoil, painted double door with decorative hinges. Leaf and fruit moulding stops at the foot of the arches beginning to show erosion, should be ok for the next 5–10 years. \*

**PORCH ABUTMENT**

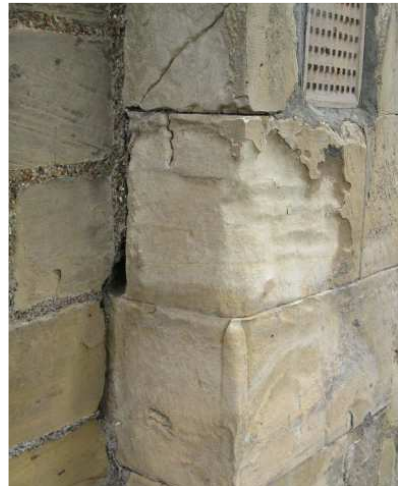
**BUTTRESS EROSION**

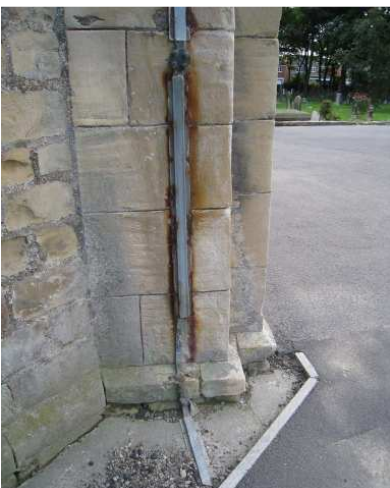
The lightning rod shielding at low level is rusting badly and coming away and needs replacing **urgently**. It is an easy theft with the potential for significant damage if a vehicle is used to rip it off \*

**EXPOSED CONDUCTOR**

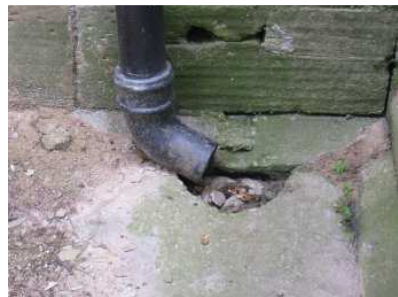
The cast iron eastern nave downpipe requires a shoe into the gulley and the cracked end pipe should be replaced. Chancel downpipe requires checking for free running and straightening up. The gulley requires forming correctly.

**REMAKE GULLY**

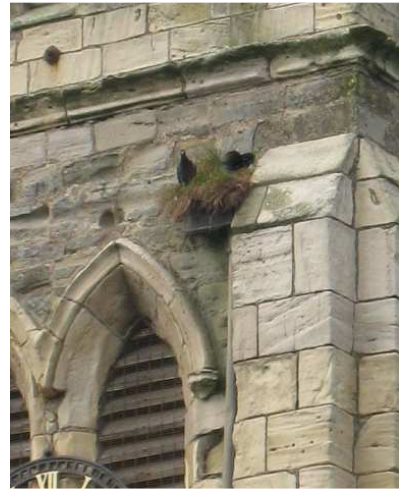
**BIRDS NEST, EROSION**

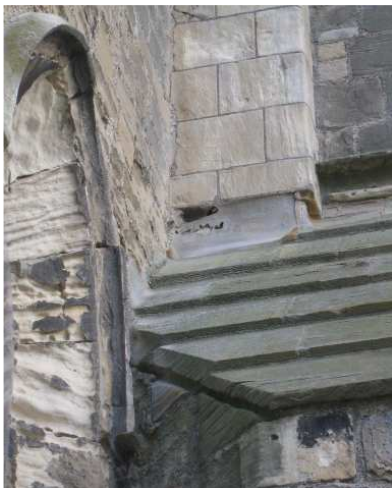
**LANCET WN1 & ROOF EROSION**

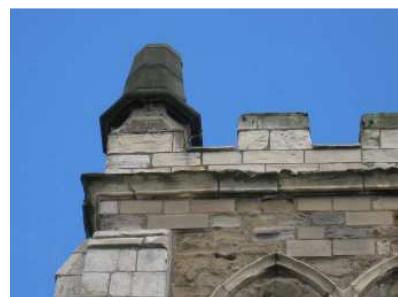
The pinnacles have open joints which need filling. They are seated well enough, though there is erosion to the south west pinnacle support, as noted earlier. The conductor is not securely fixed at the south and across the lead roof. The upstanding point on the north east has been laid over flat. The merlons are all ok. There has been some re-pointing to one on the west in cement pointing – the one on the east has had a small piece of stone silicined in and this is beginning to break down. \*

**PINNACLE & EROSION**

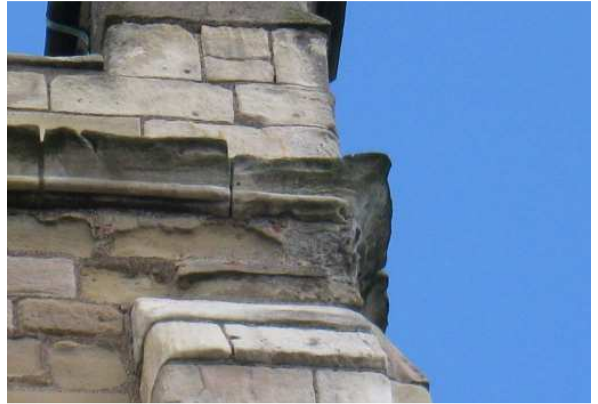
**ERODED CORNICE**

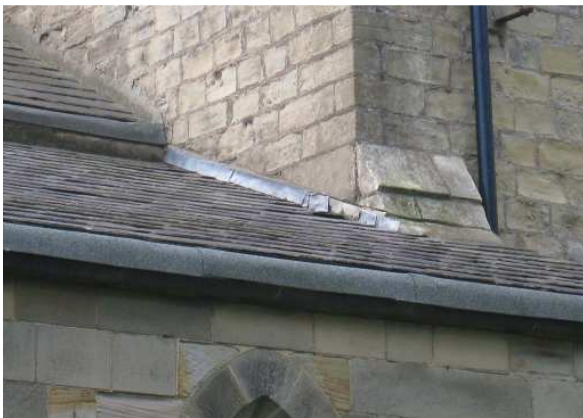
The Chancel to Nave junction mortar pointing is thin. There may be evidence \*  
of water penetration internally. Some lead flashing missing at the organ loft  
abutment to Nave. All gutters should be checked for free running.

**ORGAN LOFT ABUTMENT TO EAST NAVE GABLE**

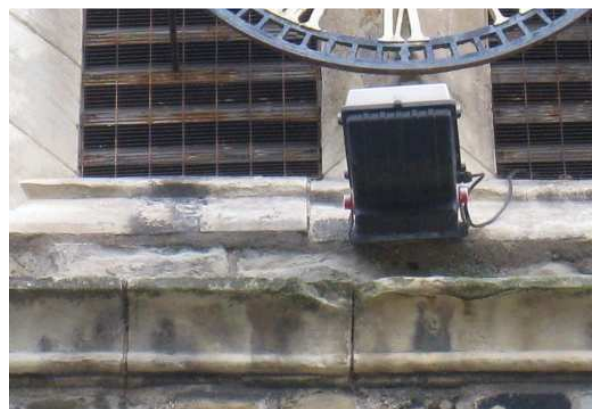
**LANCET CILL OUT OF JOINT**

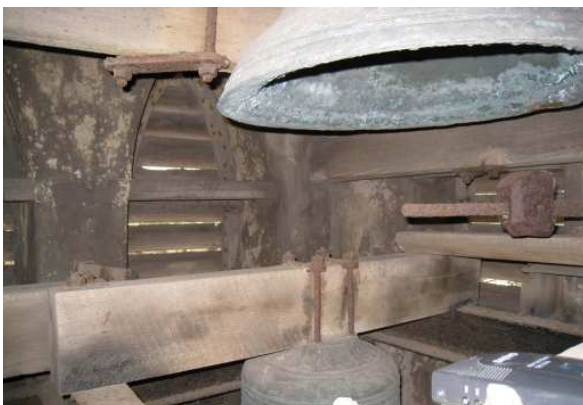
**BELL CHAMBER LOUVRES**

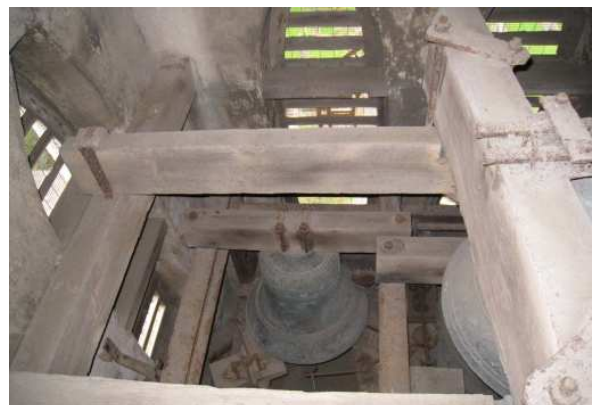
Five bells on timber and steel frame supported by steel diagonal ties built into the walling. The ties in steel work are rusting. Their expansion is beginning to push the stonework apart. \*

**RUSTING CRAMPS**

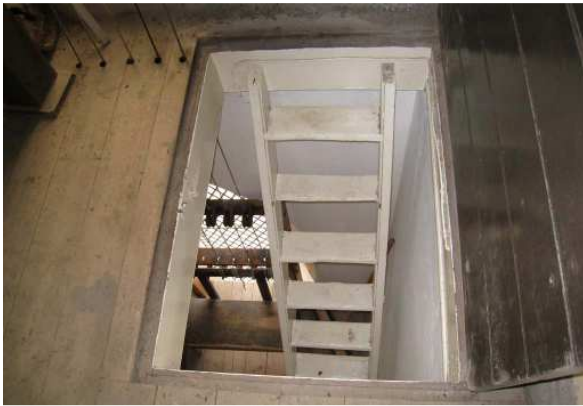
**First Stage:** This provides access to the gallery (discussed later) and provides a stage for the hand ringing of bells. The stair should have a handrail and guarding leading to the ringing chamber. Painted wall and ceilings and natural timber floor boarding which has been patched in the past. There are a couple of loose boards by the cupboard. The cupboard has the bottom plinth missing which should be patched and needs a working handle. There is electrical cable in timber conduit now painted. This needs to be understood as to whether this is live and needs covering or can be stripped out. Lighting is by surface mounted enclosed fitting. The lancet window reveals could do with brushing down and general tidy up with pointing to open joints are at keystone. \*

**STAIR ACCESS GUARDING + GATE REQUIRED**

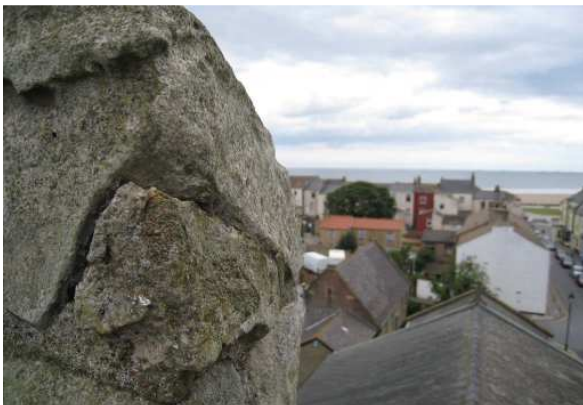
**SILICONED STONE**

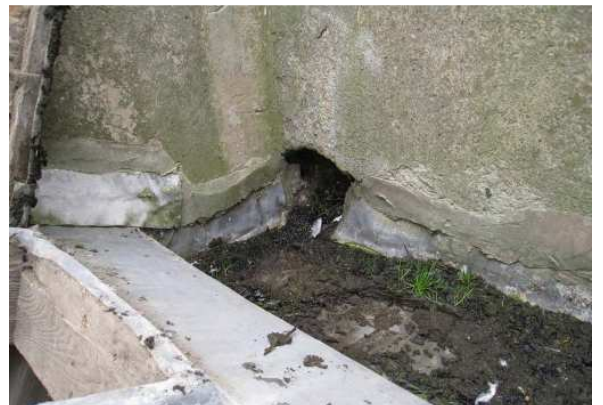
**CHOKED PARAPET GUTTER**

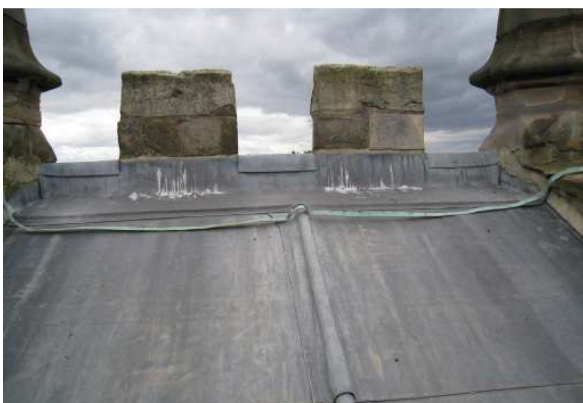
The width of the lead bays looks excessive and they have been tack welded at the lap which has broken due to thermal movement. It appears sound albeit that there is one ripple beginning to form in the left hand lower quadrant. The lead work at the higher level by the lightning conductor tape does not appear to have adequate lap and there will be wind up lift in this location. \*

**TACKED LEADWORK AND LOOSE STRAP**

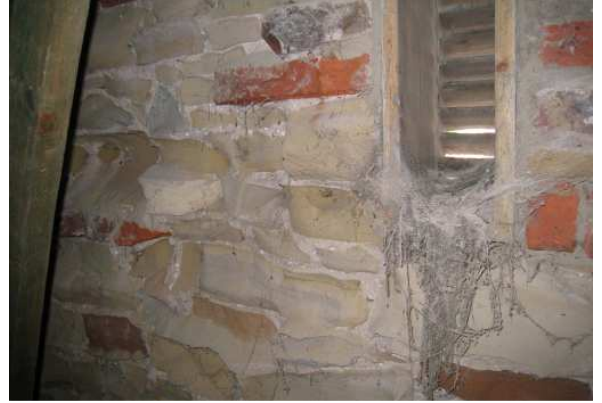
**EAST GABLE STONE EROSION**

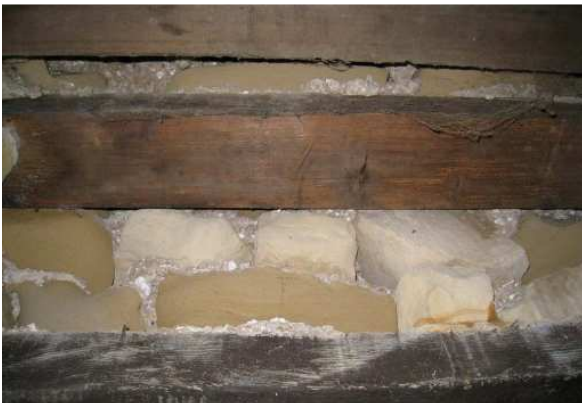
**WEST GABLE EROSION**

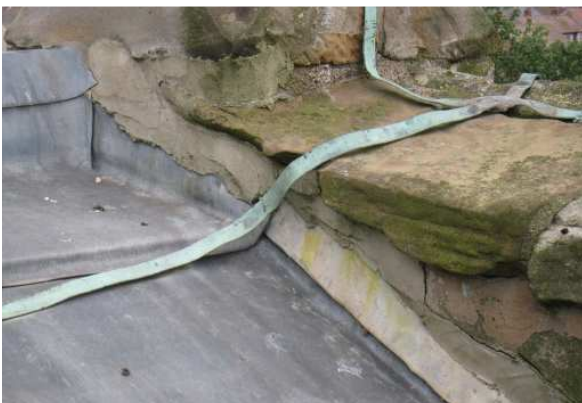
**TOWER ROOF CONDUCTOR STRAP**
