St Nicholas' Church, Durham

St Nicholas' Church stands on the north side of the Market Place of the City of Durham, with Claypath to its east and the modern Leazes Road in a deep cutting immediately to the north. The church consists of a nave with a four-bay north aisle and a tower/porch on the south, carried up as a lofty spire, with a two-bay aisle to the east of that; there is a short chancel with a single bay of aisle on each side, and a parallel vestry block to the north. The present building is an impressive High Victorian church, in a free 14th-century style, standing on the site of a medieval predecessor.

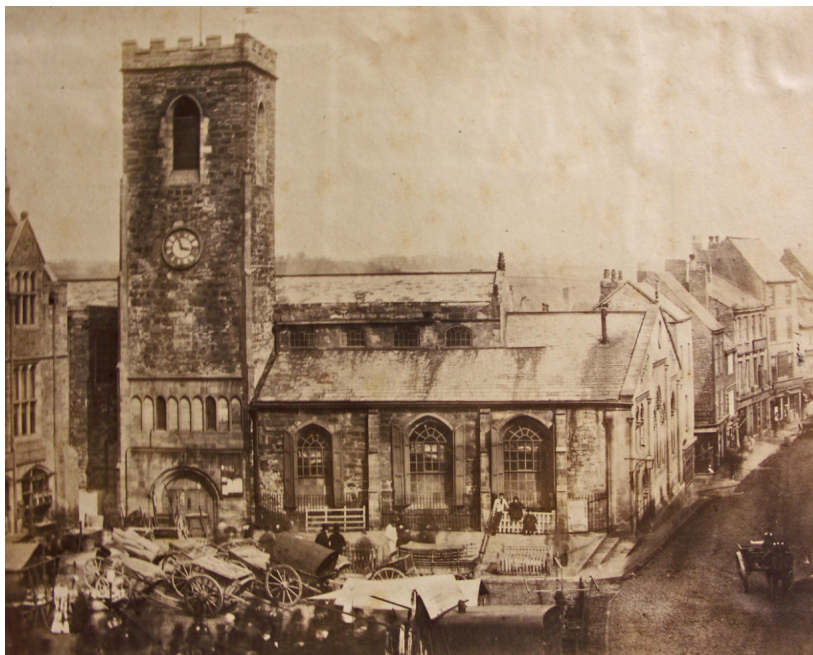
Photograph of St Nicholas' Church c1855, showing the east end as rebuilt in 1841

The medieval church was clearly subject to extensive post-medieval alteration, as the surviving illustrations of the south side of the building make clear. The one photograph⁷ shows large sash windows in the south aisle, and apparently neo-Romanesque detail to the east wall rebuilt in 1841. The Victoria County History account states that a 'Norman' style window, presumably from this wall, has been re-used at Edmondbyers parish church⁸. The tower, as shown on the photograph, looks much altered; the large doorway with its almost round arch, and the arcade of small arches above, might have been of 15th century date (Sir Stephen Glynne talks of a 'good perpendicular' porch, after mistakenly locating the tower at the north-west angle) but their stonework looks 'fresh' and may not have been all that old; the tower's spindly diagonal buttresses also look recent, or more likely old ones trimmed down almost into non-existence. The north-western vestry was a three-storeyed block looking very much like an attached house.

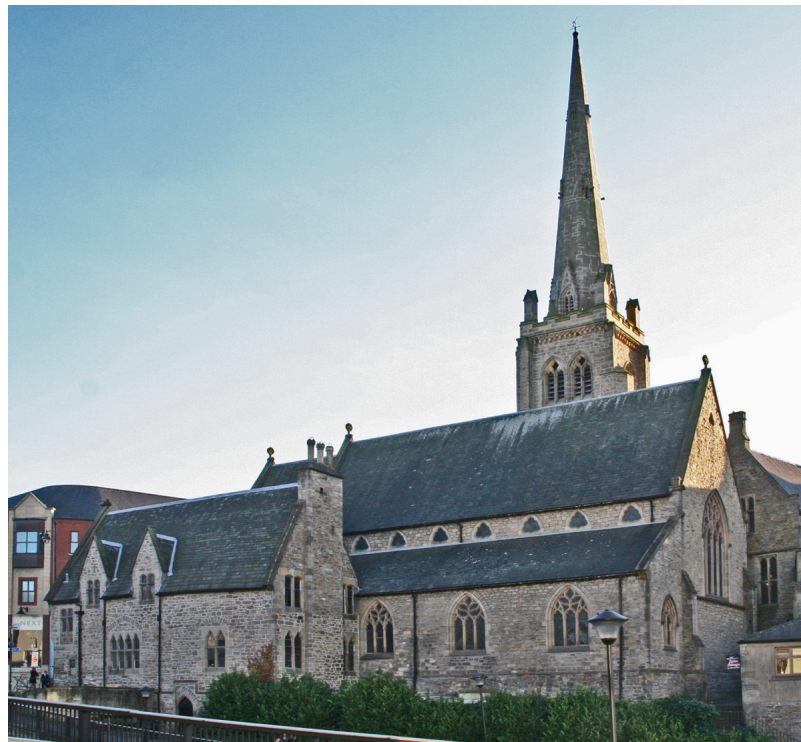
The church seen from the north-west, across the modern through-road (Leazes Road) (c1970) which runs on the line of the former town walls.

The north elevation of the church, formerly raised directly on the city wall, now stands high above the modern Leazes road; apart from a chamfered plinth, there is little architectural detail. The nave aisle has a two-light window in its west end and three three-light ones on the north; the eastern bay of the aisle is now concealed by a westward extension of the vestry block. Above the aisle is a range of eight spheric triangle windows in the clerestory.

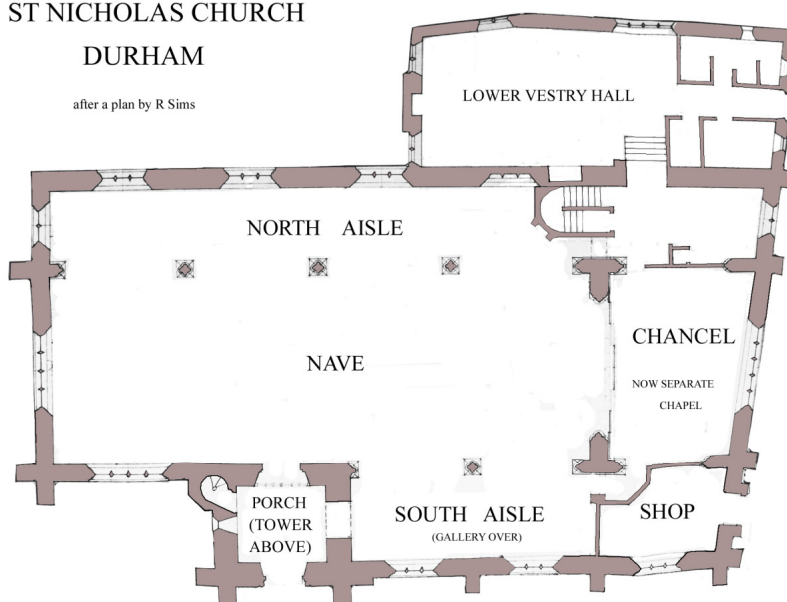
ST NICHOLAS CHURCH
DURHAM

after a plan by R Sims
