# **Egglescliffe Parish Church County Durham**

## **An Archaeological Assessment**

1993 revised 2004

**Peter F Ryder**

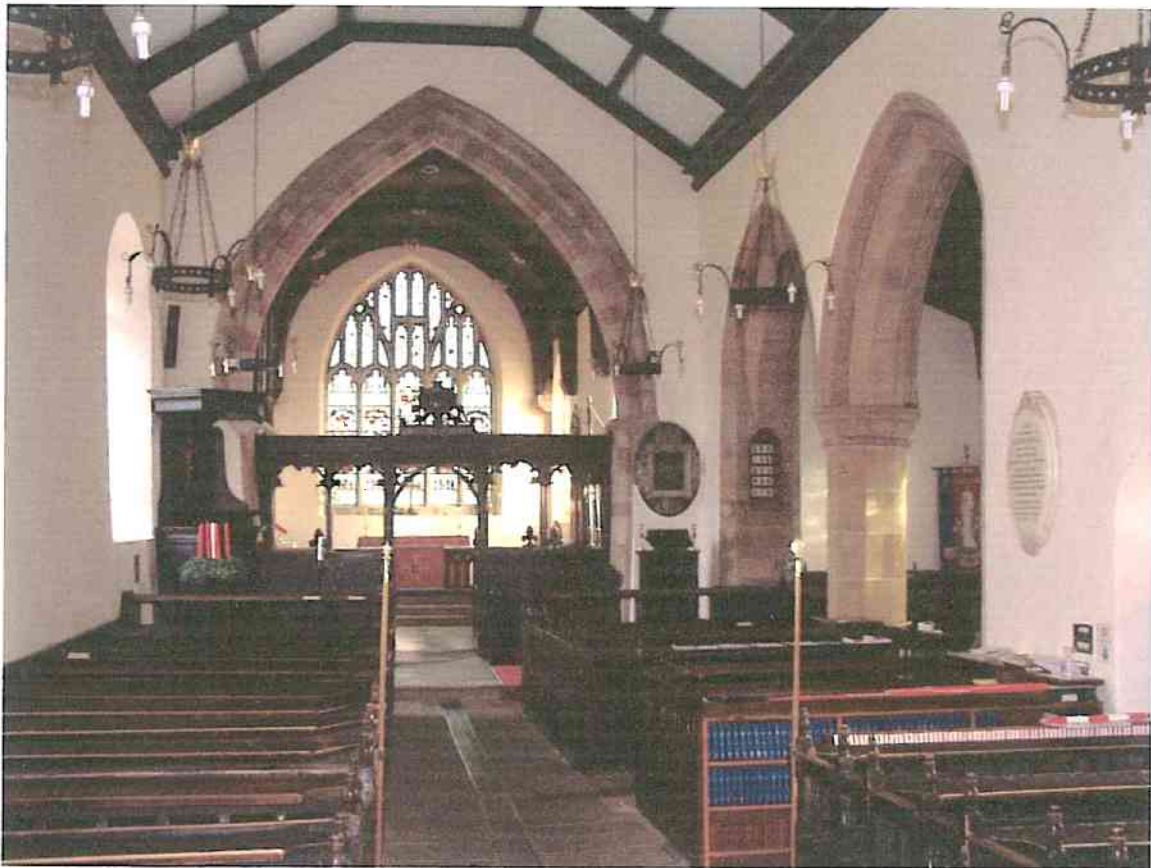
Interior looking east

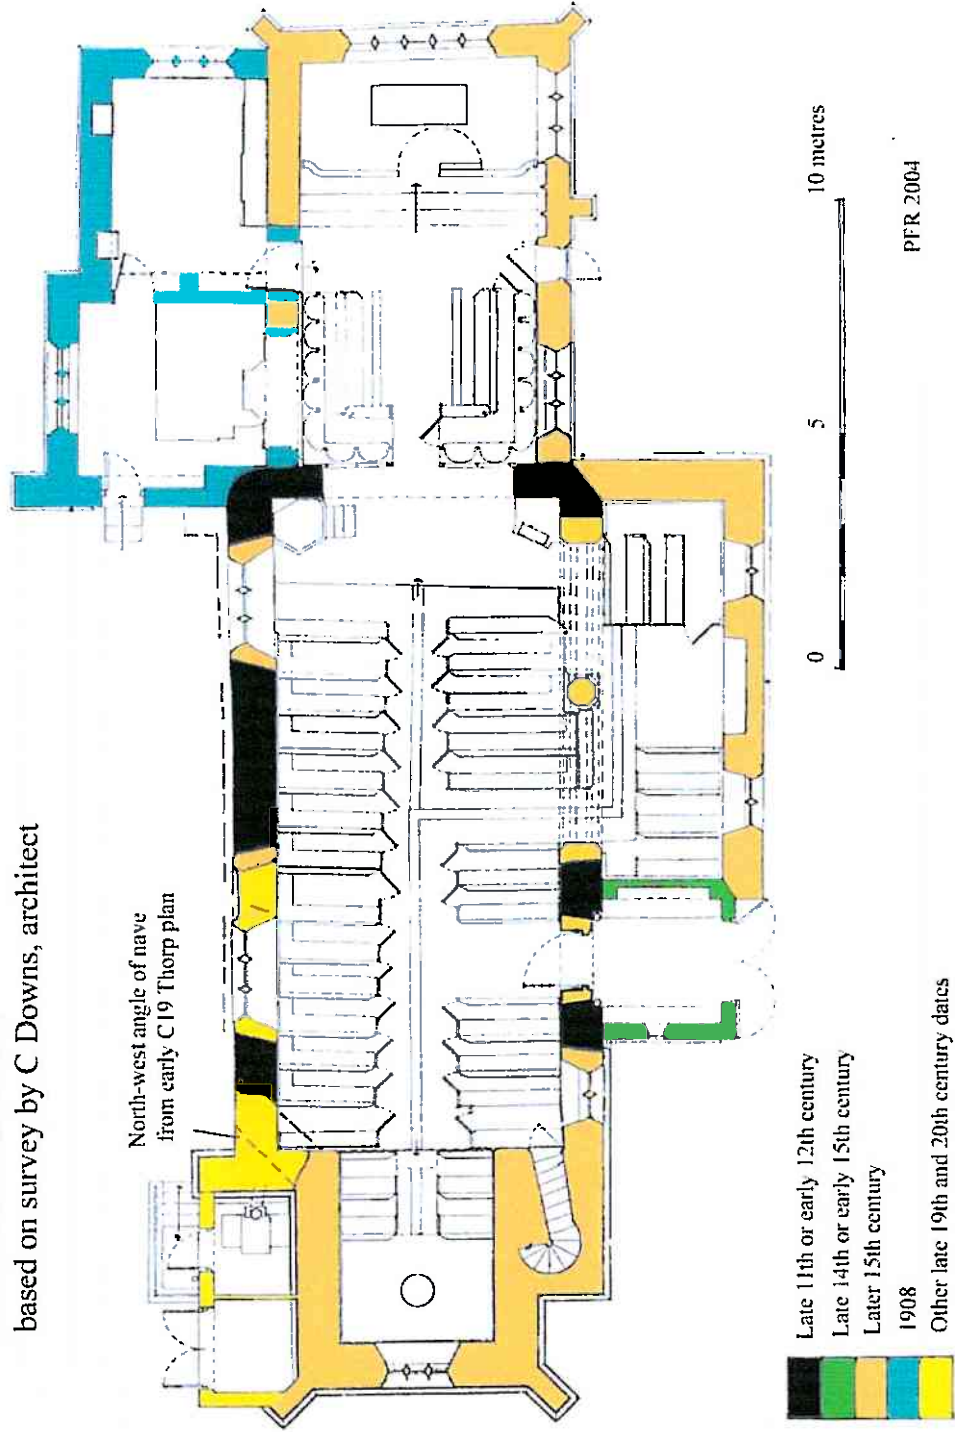
Provisional Phased Plan

based on survey by C Downs, architect

The overall picture of the development of the church - a late 11th or early 12th century core remodelled towards the end of the medieval period - is quite clear, but some details, in particular the date and phasing of the remodelling, remain uncertain.

Parts of the nave walls, the original south door, and the re-cut jambs of the chancel arch, survive from the earliest building. The remainder of the building is of later medieval date. The remodelling of the chancel arch is sometimes seen as of 13th century date, but the arch itself is of such 'standard' elements (chamfered orders and chamfered hood) that it could equally well be 14th or even 15th century. The south aisle (variously termed the Aislaby Aisle, Hyndmer's Porch and Pemberton's Porch) is generally seen as a mid-14th century addition (possibly as a memorial chapel to Sir Thomas of Aislaby, d.1291, whose presumed effigy still lies within it), although its architectural features look more of 15th century character; its relation to the porch suggests that the porch is the earlier addition. Structural evidence suggests that the porch had a separate gabled roof, before its parapets were raised to conform with those of the adjacent aisle. The most refined architectural features are found in the chancel, which certainly appears of mid-15th century date; it would be difficult to place the flattened four-centred arches of the sedilia any earlier. The tower also looks of 15th century type, although some features - the set-back on the south and the variety of fabric types seen inside the stair turret - suggests that some fabric may survive from an earlier tower.
