Escomb

The parish church of St John the Evangelist¹ at Escomb, on the south bank of the Wear 2 km west of Bishop Auckland, is called by Pevsner & Williamson (1983, 267) ‘one of the most important and moving survivals of the architecture of the time of Bede’ and is arguably the most complete Anglo-Saxon church in England. The building has justifiably attracted considerable antiquarian interest over the last century and a quarter.

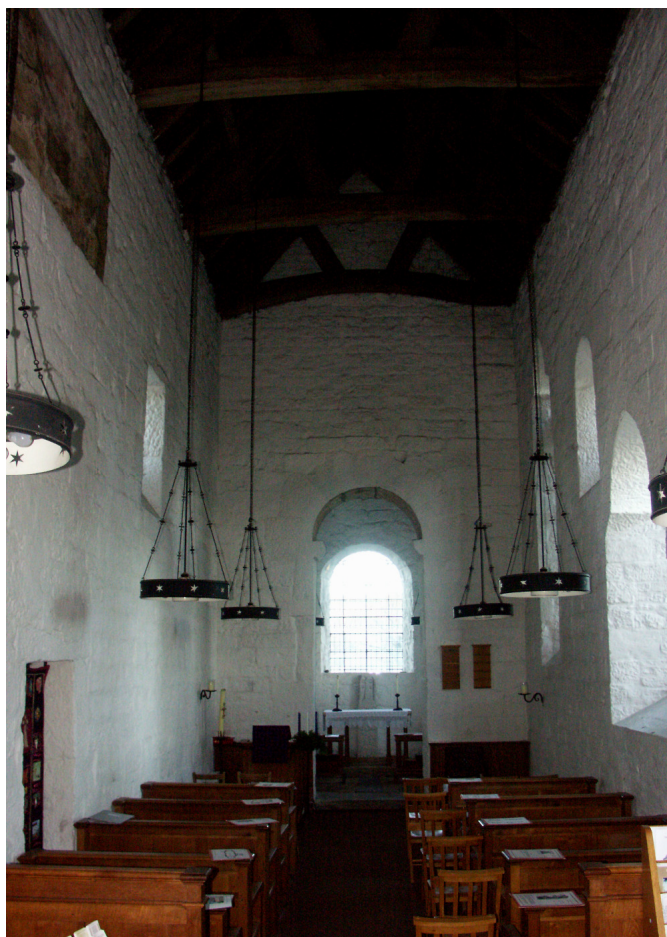
One descends three steps from the porch to the carpeted floor of the **Nave**. In the west wall of the nave the large window is obviously an insertion; its jambs are splayed but not its head, and it has a level sill. On the north of the window and c 1 m above its sill is an infilled socket, possible evidence of a western gallery. Above the window the walling seems undisturbed; high up, a roof truss partly obscures the high-level window which has a very rough rear arch, with a vertical V-section groove cut into its apex that presumably took a bell rope.

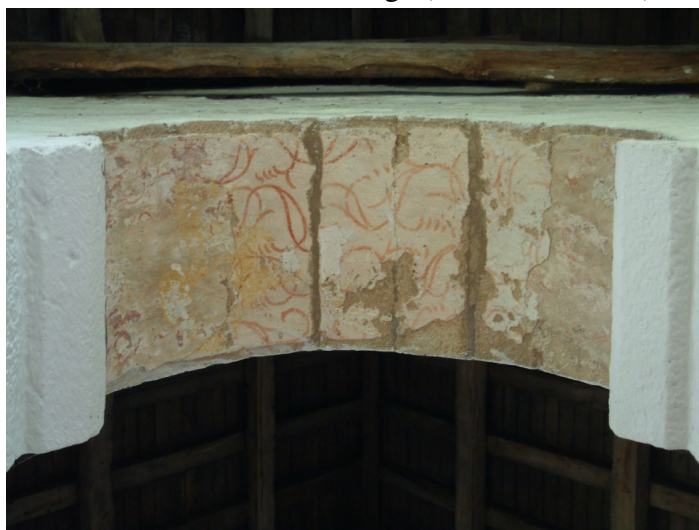
The arch into the **Chancel** is set in the centre of the east wall of the nave; it is 1.6 m wide and 4.6 m high, and of semicircular form and a single square order; the impost only project on the soffit, and are chamfered on their lower angle. Both jambs and arch are made up of through stones; the jambs are made up of alternating upright and 'long' stones, and the arch of neatly-cut voussoirs. On the south the impost and upper part of the jamb below are cut from a single block. It is often stated that this arch is, like the tower arch at Corbridge (Northumberland) a re-used Roman feature. The

soffit of the arch is left clear of whitewash as it bears relatively well-preserved remains of medieval wall painting⁶, intertwining tendrils of foliage in orange/red on a pinkish ground. On the north of the arch there is a small incised cross on the wall behind the pulpit, c 1.8 m above the floor; this is thought to be contemporary with the fabric.
