## All Saints Church, Great Stainton

### Architectural Description

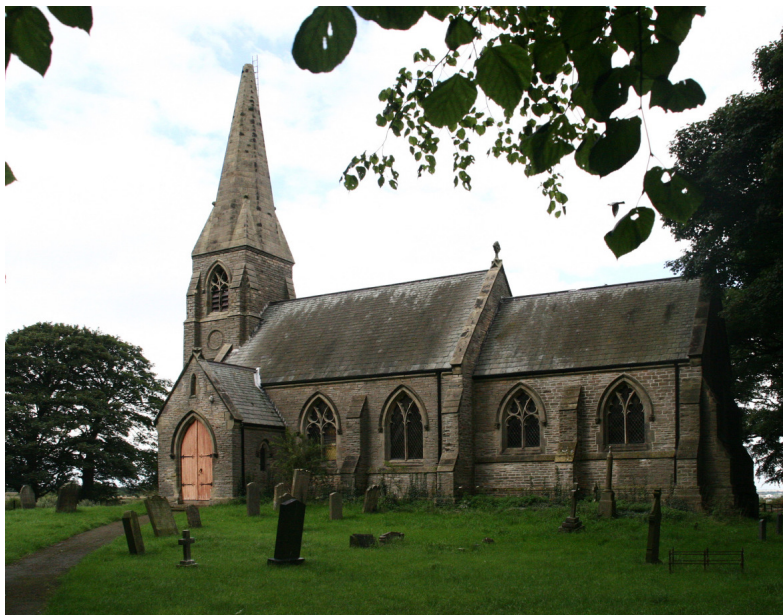
The church is constructed of rough-faced stone, in quite thin courses (which vary in height), with smooth sandstone ashlar dressings. The roof is of graduated Lakeland slates. The present building (right, south-east view) is entirely of 1876, and in a free Decorated style. The two light windows are generally in two alternating forms, one with two cinquefoil-cusped lights and a pierced quatrefoil in the

spandrel, the other with cinquefoiled four-centred lights with a cusped mouchette above each; the latter form is used for the belfry openings. There is a chamfered plinth (doubled in the chancel) and a big chamfered off-set below the windows; the walls are articulated by broad stepped buttresses (paired at the angles) with deep sloping set-backs. There is a chamfered oversailing course to the eaves, and the gables have a slab coping, chamfered on the underside, carried on chamfered kneelers, with finials on cross-gabled bases. The roofs are of graduated Lakeland slates.

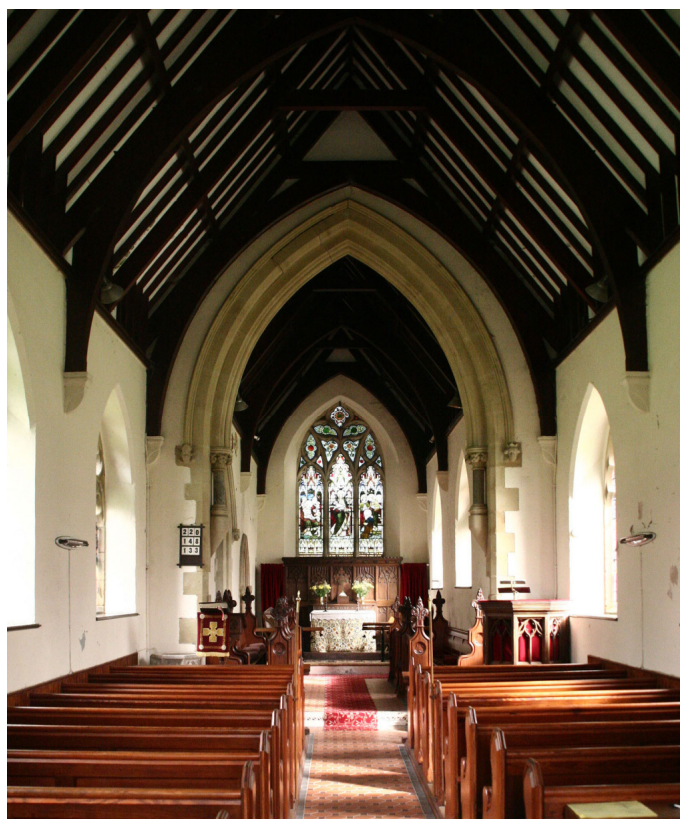
(left) Interior looking east

The interior of the whole church is plastered and whitewashed, except for the exposed ashlar dressings of the various arches; the windows and south door all have segmental-pointed rear arches, with chamfers to their heads only. The windows all have horizontal timber sills.

The arch into the **Chancel** is two-centred; the moulded inner order is carried on pilasters with foliate caps, marble shafts and moulded bases, carried on corbels c 2 m above the floor, and has the usual moulded hood and head stops - a king on the r., and a bishop on the l. At the west end of the north wall of the chancel is a segmental-pointed arch to the organ chamber,

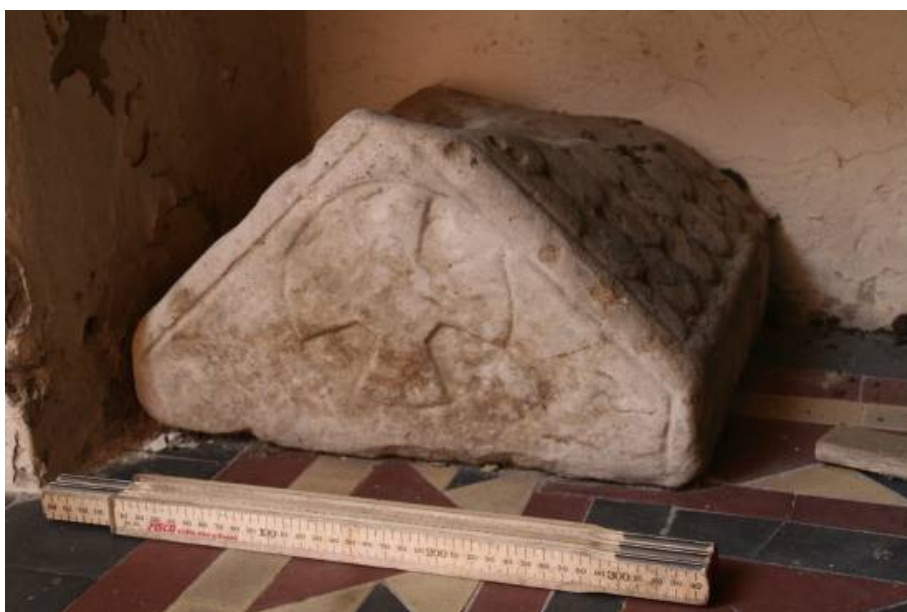
There is also a section of a 12<sup>th</sup>-century coped slab, now lying loose in the south porch, with tegulated sides and a splay-armed cross within a circle on the end.

Coped and tegulated slab in south porch;  
a vulnerable section of an important 12<sup>th</sup>-century monument

A more significant area of archaeological concern is in the condition of the lapidary material preserved in the church - the important piece of Anglo-Saxon cross shaft and good medieval tegulated grave cover in the porch, and various stones currently lying under the pulpit, and the medieval and post-medieval slabs built into the internal walls of the tower. Since the loss of the church fabric in 1876, these (together with the font) are the most tangible relics of the earlier history of the parish, and are worthy of protection. Lichen growth is affecting the slabs in the tower walls, and those lying loose in the porch and around the pulpit should really be inspected by a conservationist, and stored, perhaps on wooden shelving, in a more appropriate manner. A search of the rockeries of the former rectory might also be a good idea.
