**DIOCESE OF DURHAM  
HOLY TRINITY CHURCH,  
SEATON CAREW, COUNTY DURHAM TS24 7QX**

**INSPECTION OF CHURCHES MEASURE 1955  
CARE OF CHURCHES & ECCLESIASTICAL JURISDICTION MEASURE 1991  
QUINQUENNIAL INSPECTION 18 AUGUST 2010 AND REPORT OCTOBER 2010**

**David Beaumont BA (Hons) GradDip, RIBA, AABC**

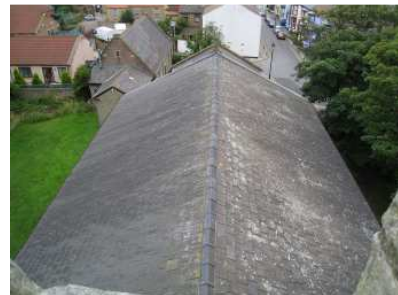
**NAVE ROOF**

There are some ridge tiles and slates to replace, but the roof surface is in generally good condition. The vestry features mineral felt gutters, as a result of lead theft and it would be preferable to revert to leadwork as the material would provide a long service covering. It is understandable that re-occurring lead theft would make this unviable – so, when the felt gutters break down, it will be appropriate to replace them in a more durable rubber compound that can be hot air welded in grey colour. The rainwater goods are principally cast iron and require redecoration. The nave has a plastic downpipe which could be replaced. The downpipe from the sanctuary to the vestry has an elementary connection in leadwork to the downpipe, which is creased and folded and this should be remade. The east elevation tower downpipe needs a directional shoe to direct water away from the nave roof lead flashing abutment and above this point the chute from the tower roof needs the birds nest removing, stonework repairing and lined with leadwork.
