## The Parish Church of St Ebba, Ebchester

St Ebba's parish church stands in the centre of the village of Ebchester, on the south-east side of the Derwent valley; its well-wooded churchyard lies within the site of the northernmost of the series of Roman forts on Dere Street, the major Roman road running from York to Hadrian's Wall and beyond.

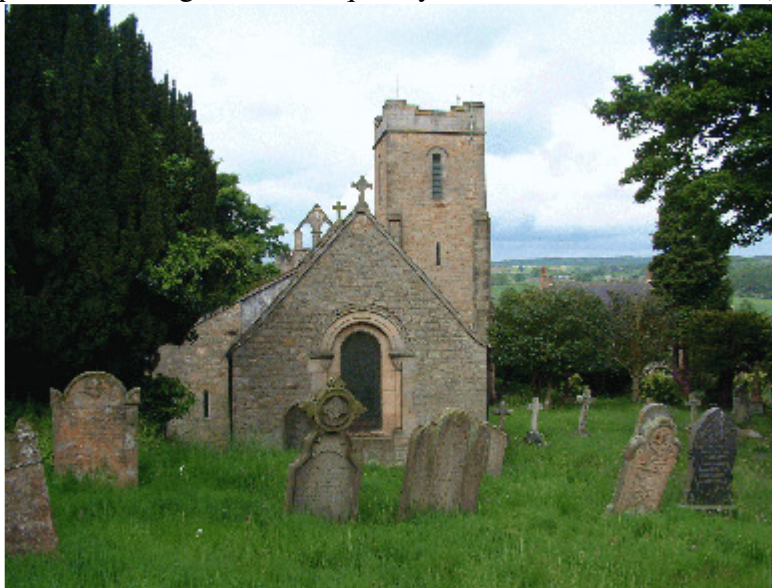
The east end (left) has a small offset around 1.0 m above the plinth, evident to the south of the window, and also, unusually, cut into one of the large blocks of the north-east angle quoin. The large Romanesque-style east window of 1876 (replacing a square-headed sash)

has an inner order with a continuous chamfer, and a moulded outer order that is carried on jamb shafts that have scalloped capitals and imposts chamfered on their lower edges, which also carry a hoodmould with chevron ornament. The gable above has a cross with a disc at its centre as a finial.

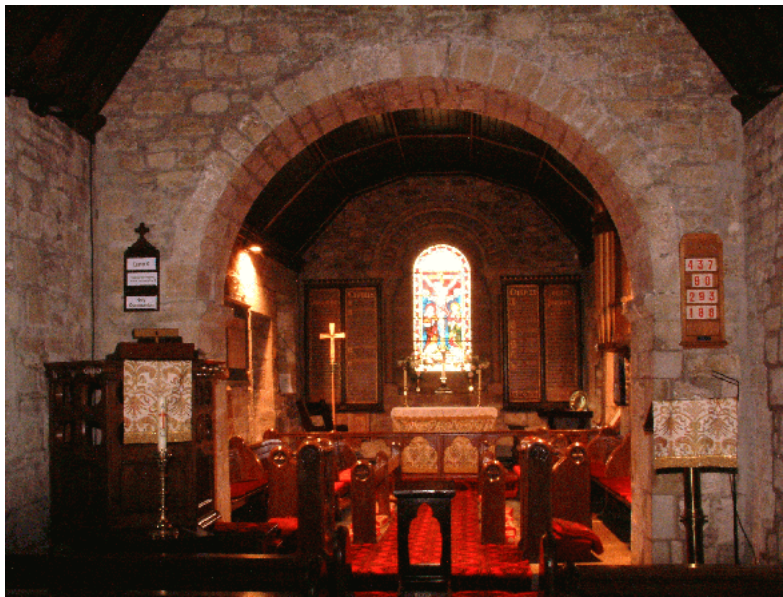
The western part of the original south wall of the chancel has been removed by a broad opening to the organ chamber of 1907, spanned only by a timber plate; its chamfered east jamb includes some tooled-and-margined blocks. The internal lintel of the western of the two windows in the eastern part of the wall is set a little lower than that of eastern. The internal jambs and sills of both windows, and of all three in the north wall, look ancient., although some stonework has clearly been re-set; the western window on the south and the central one the north replace pre-1876 sashes<sup>2</sup>. The only old feature in the east wall is an aumbry, set towards the north end, but its original form and fabric is now completely concealed by new oak doors and a concreted-in wall-safe, which is unfortunate as it is reported to have had

fittings for a door ‘unusually hinged at the top so that it opened upwards’ (Downie 2002, 26). There is no sign of any other of the usual ritual arrangements (other than cuts for previous altar rails) or of the stone benches said to have been found in the chancel walls in 1876. The east window is of similar form internally as externally, except that its outer order has a form of billet moulding, probably modelled on that around the font, rather than chevron; the wall on either side is hidden by the creed and commandments boards, whilst that above it is of 1876 snecked stone.

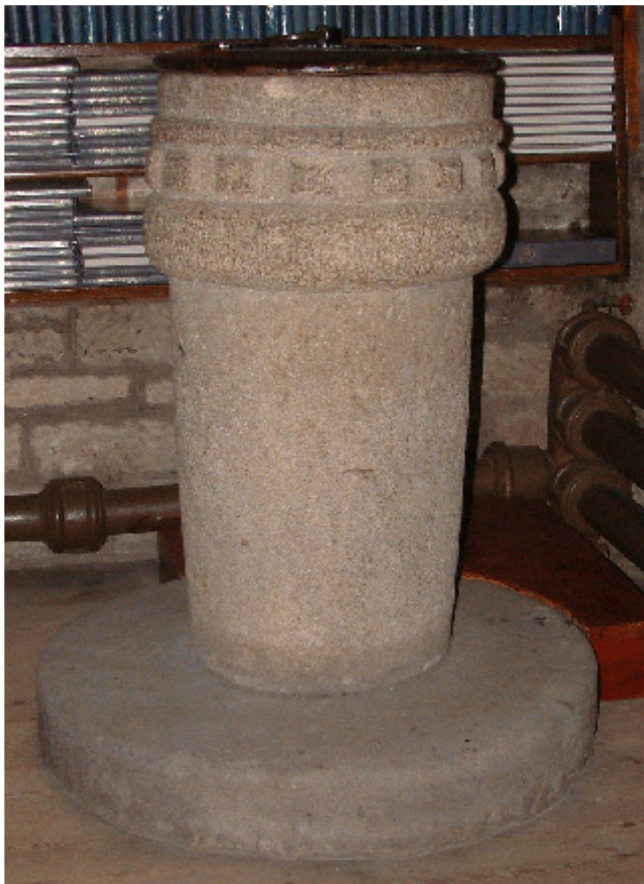
The **Font**, (left) at the south-west corner of the nave, is of considerable interest, and may be contemporary with the church. It has a circular shallow bowl with simple but heavy mouldings on the vertical face, including a line of large billet ornament ; the shaft, tapering slightly downwards, is of little less diameter than the bowl, and rises from a circular base which may be a former (Roman?) millstone.
