St Andrew's Church, Sadberge

An Archaeological Assessment

March 2001

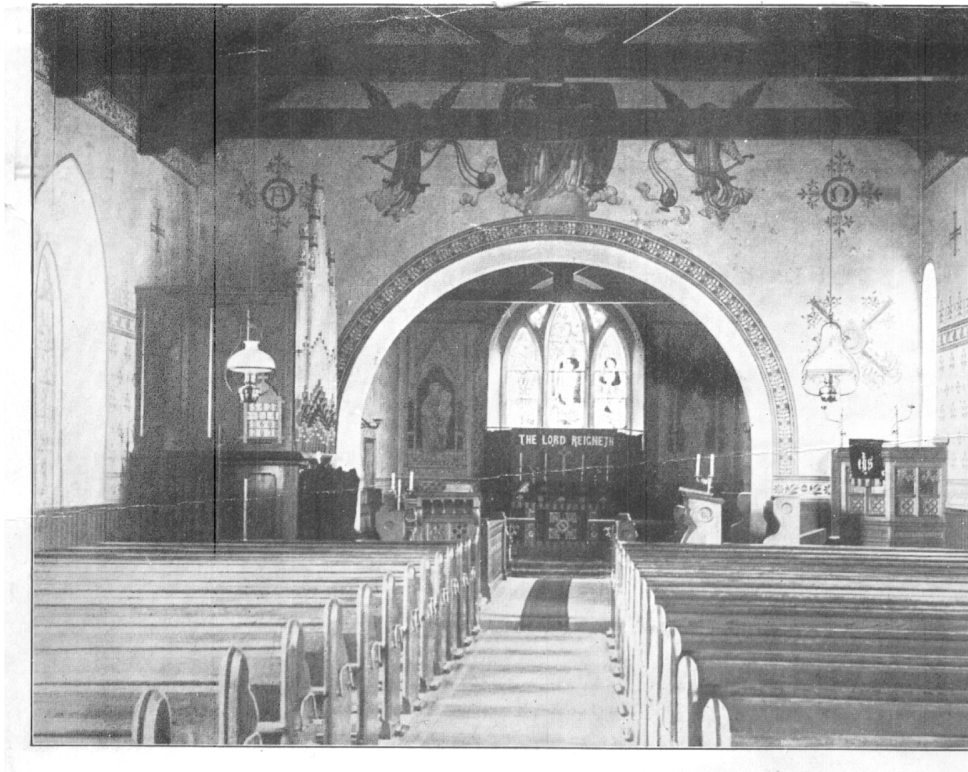
Church interior (from Lancaster Taylor, 1919) showing 1890 scheme of decoration
