The Parish Church of St John, Elton

This is a small church, largely of 1841, consisting of an aisleless nave with a south porch, and chancel with a north vestry.

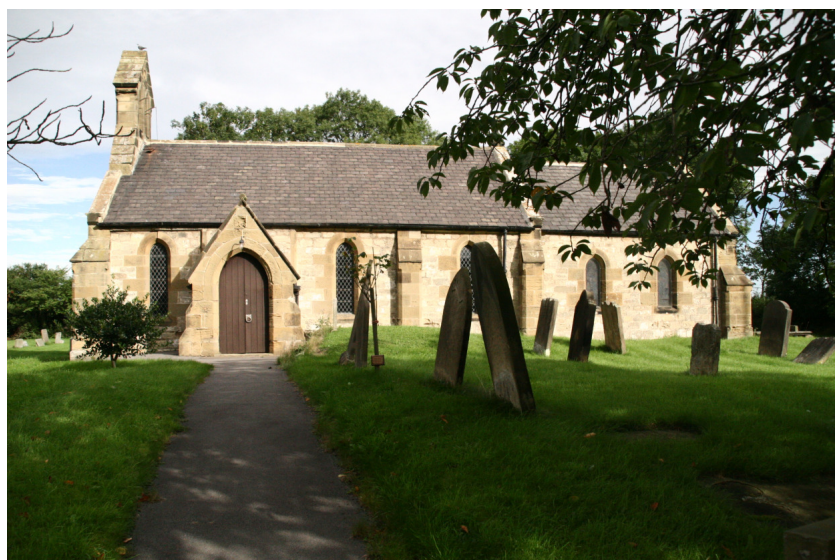
On the south (left) there are lancet windows in the first, third and fourth bays, the wall of the second bay, behind the porch, is thickened externally, a chamfered oversailing course at eaves level being returned vertically down each side of the projection. There are broad buttresses, continued up to the eaves, between the third and fourth bays and at the

east end of the wall. The west bay has a chamfered plinth continuous with that of the south-western buttress, but further east the ground level is higher and any plinth is buried.

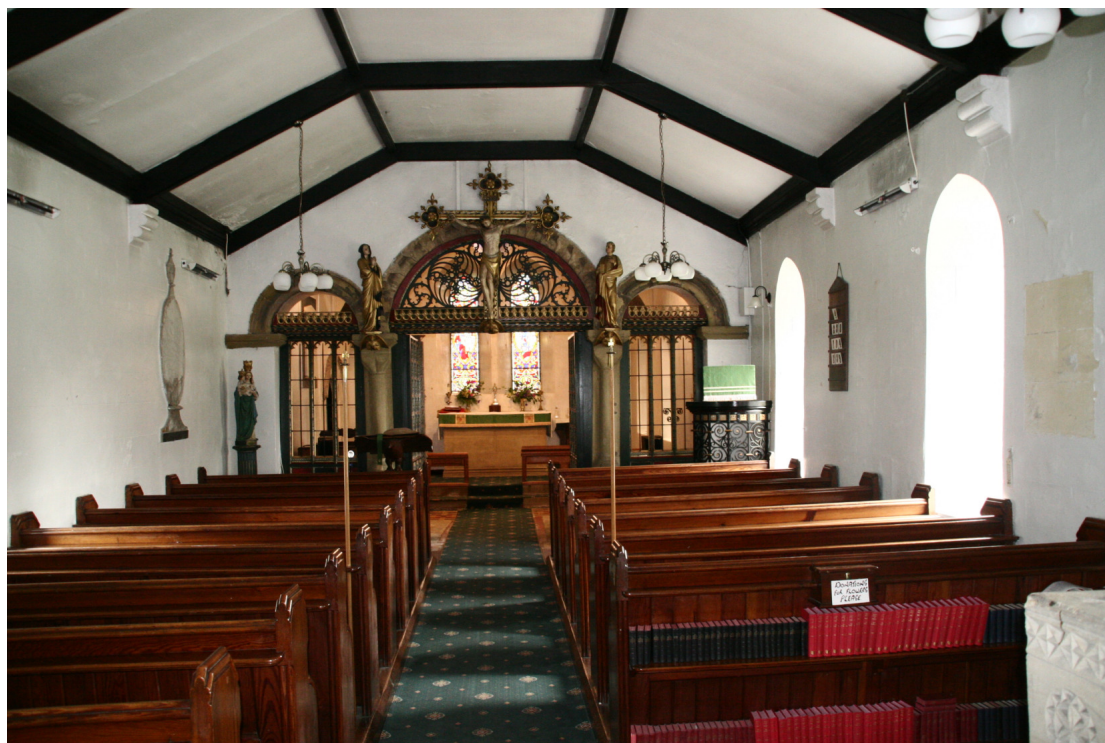
The internal walls of the church are faced with some form of Roman cement or hard plaster, lined to simulate ashlar, and painted; the only exposed dressings are those of the chancel screen and re-used 12th-century features. All the windows have plain two-centred rear arches without exposed dressings

The dominant feature of the church interior is the triplet of Romanesque-style arches between nave and chancel, and their 1907 screen. The larger central arch has a roll mouldings and beak heads that look as if they have been cut back, and springs from rectangular ashlar piers with attached semicircular shafts on their western faces, with moulded bases and scalloped capitals. The smaller flanking arches each have a fat roll moulding flanked by hollows; all have impostes that are grooved and chamfered on their lower angles, the outer ones being continued back along the east wall of the nave. The flanking arches have ashlar sills c 0.8 m above the floor. It is not clear how much of this composition is ancient; the Victoria County History (1928, II, 234-5) is certainly wrong in stating that ‘the whole of the stonework is original’. The voussoirs of the central arch look old, if re-cut, and the two narrower voussoirs of the northern opening - and possibly the outer impostes - may be old. The lower part of the southern jamb has an odd step-back or rebate, up to its mid-height, with a triangular stop above; this gives the impression of earlier fabric re-worked, although it might simply relate to the 1841 pulpit that stood here.
