## The Parish Church of St Hilda, Hartlepool

### Description

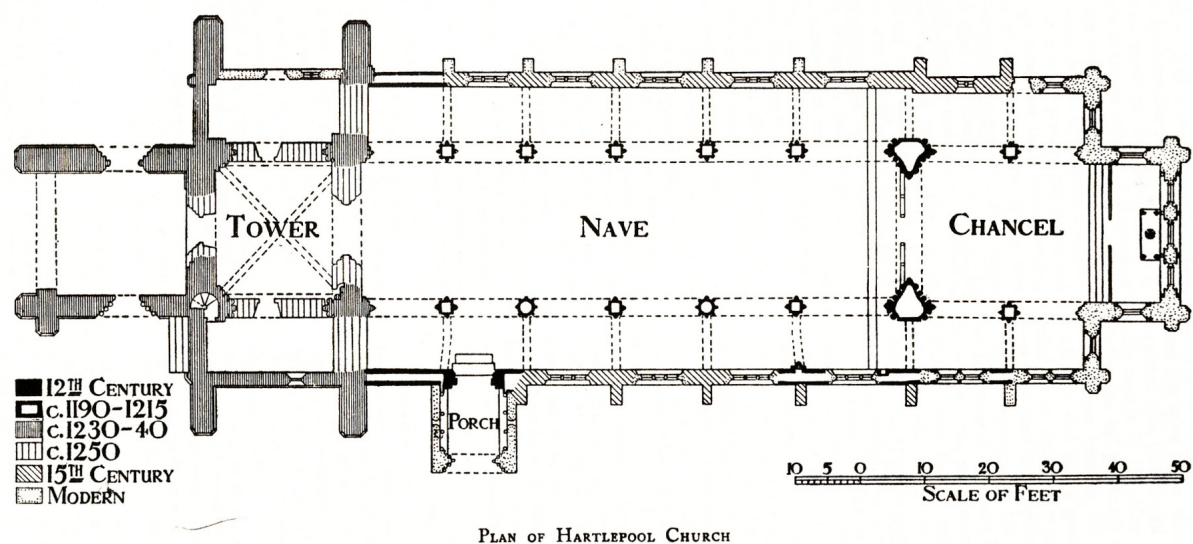
Ground Plan of the Church from Page (1913), before the 1925-1932 extensions
